Inspection Report

KDG Sample

Property Address:
1234 Your Street
Yourtown WI 54321

Date: 9/17/2008	Time:	Report ID: 080917
Property: 1234 Your Street Yourtown WI 54321	Customer: KDG Sample	Real Estate Professional:

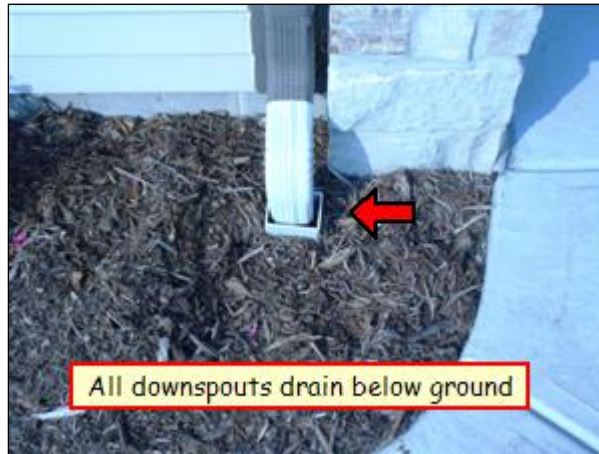
1.5 Picture 1

(2) All downspouts drain below ground and I am unable to determine if drains will function properly. This is for your information.

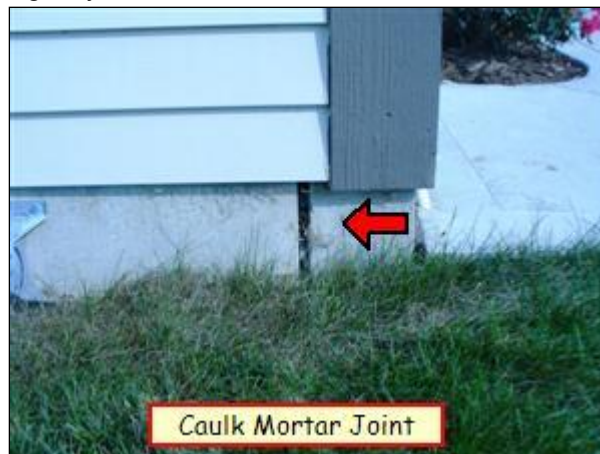
2.5 Picture 1

2.5 (Picture 1) It is recommended that mortar joints be filled or caulked to prevent moisture from entering. When moisture enters and freezes excessive cracking may occur.

(Picture 1) It is recommended that mortar joints be filled or caulked to prevent moisture from entering. When moisture enters and freezes excessive cracking may occur.

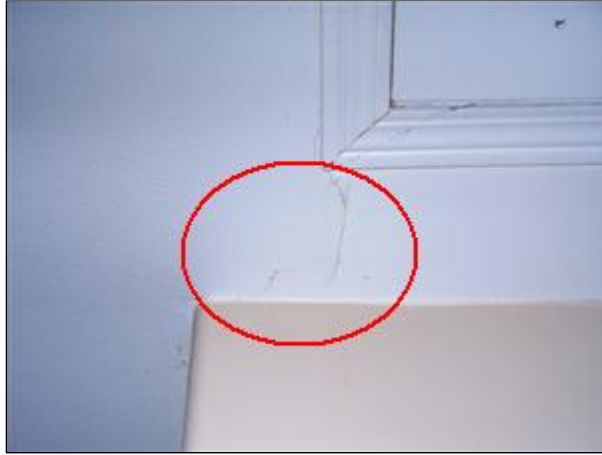
3.2 Picture 1

3.2 Sheetrock on ceiling has hairline cracks at garage. This is a cosmetic issue for your information.

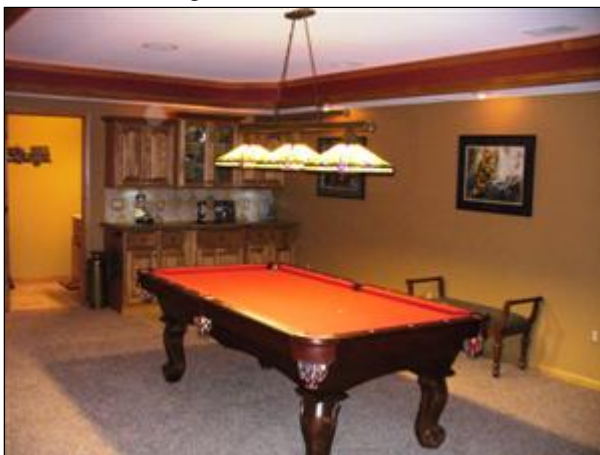
7.1 Picture 1

7.1 Most walls and ceilings in finished basement are covered and structural members are not visible. No obvious problems discovered. We could not see behind these coverings.

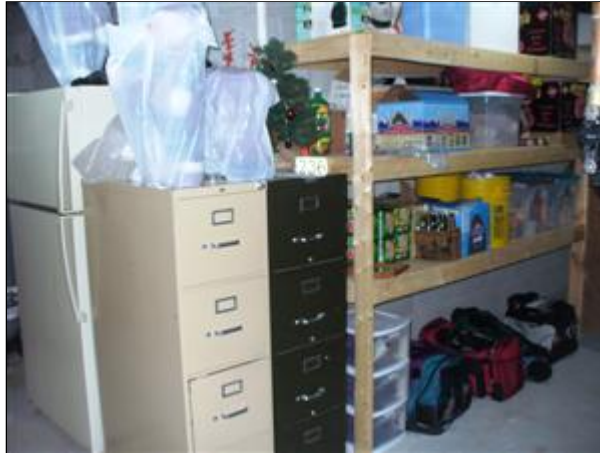
9.6 Picture 1

9.6 Storage of personal belongings / materials limits visual inspection of basement area. Storage of these items in the basement area has the ability to cover / conceal historical clues and or damage to building components. Visual inspection was limited. Recommend further evaluation if future conditions allow for.

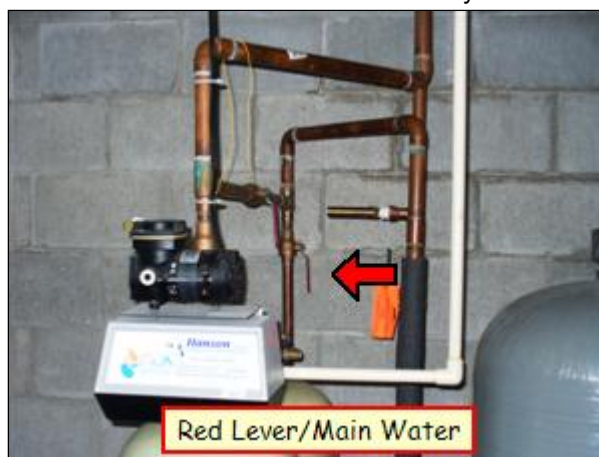
10.2 Picture 1

10.2 The main shut off is the red lever located at furnace room. This is for your information.
